# RF Test Gage R&R Improvement

James Oerth and Mike Downs

Skyworks Solutions, Inc  
20 Sylvan Road, Woburn, MA, 01801, USA  
Tel: (781) 376-3076, Email: jim.oerth@skyworksinc.com

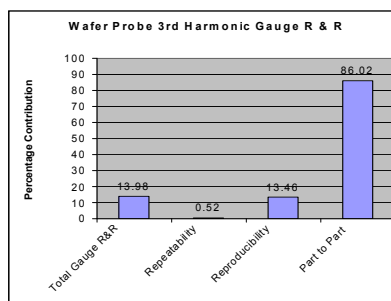
Figure 1  
Third Harmonic  
Gage R&R Results

setup was taken apart, put back together and the die tested again. Each of the four operators did this three times each. This maximized variation by requiring all electrical connections between the tester and the prober to be remade, the probe card to be reset, and the probe pressure adjusted each time. The top level results of the Gage study are shown in Figure 1. The total Gage study result was 14%, which is marginally passing. Results of less than 10% are considered acceptable. Results between 10% and 30% are marginal. Results greater than 30% are unacceptable. The repeatability portion of the Gage study indicates the amount of variation due to the measurement equipment. This result was very good at 0.5%. The reproducibility portion of the Gage study indicates the amount of variation due to the operator. This result was marginal at 13.5%.

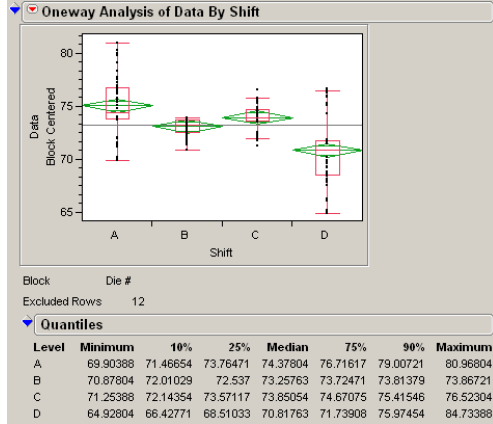
Table 1 Third Harmonic in (dBc) Results by Shift

The third harmonic variation was analyzed by operator (shift). Systematic differences between operators were observed (Figure 2). Further, the difference between operators was larger for better performing parts. We look at it as you can make a good part bad, but you can't make a bad part good. Note the data is shown in dBc. This is the third harmonic power level relative to the input power.

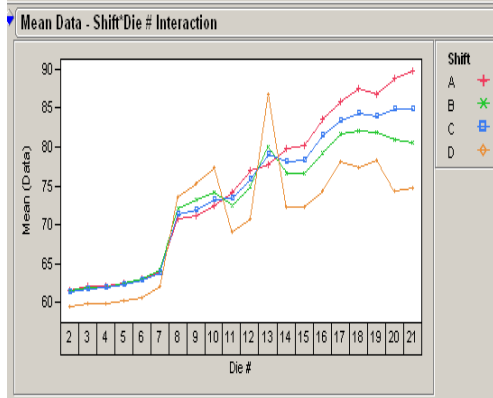
Figure 2 Graphs of Third Harmonics By Part and Shift

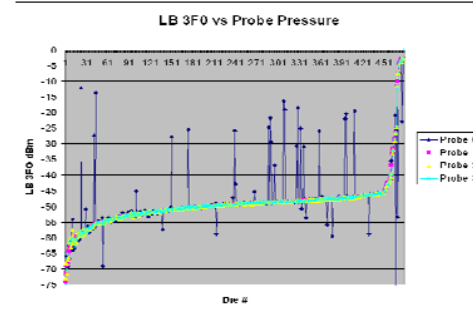
Figure 3 Third Harmonics by Probe Pressure

To evaluate the effect of probe pressure, the third harmonics were measured on the same die on the same wafer using four different probe pressure settings. A new, never been used before, probe card was used to make the measurements. This eliminated any variation due to a worn or non-planar probe card. The four probe settings were 0, 0.1, 0.2, and 0.3 mil over travel. The “zero” pressure was when the experienced operator believed all probes were touching the bond pads. The results are shown in Figure 3. The “zero” over travel setting resulted in highly variable results. The 0.1, 0.2, and 0.3 mil over travel reading resulted in reproducible measurements (Figure 4). The data shows with

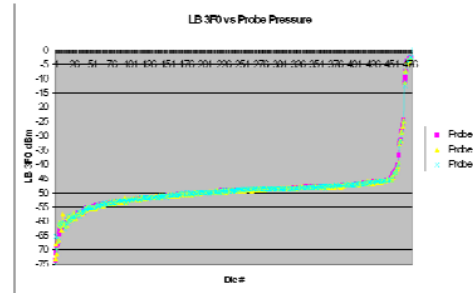
Figure 4 Third Harmonics by Probe Pressure

a new, planar probe card, an over travel of .1 mils is sufficient to obtain reproducible 3rd harmonic measurements. By inference, maintaining probe planarity is critical to obtaining consistent measurements.

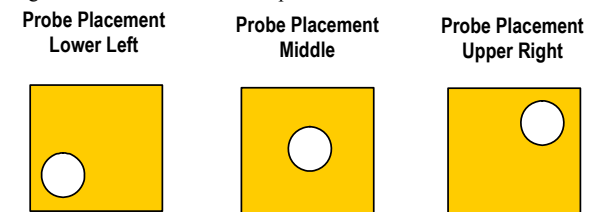
Figure 5 Illustration of Probe Tip Placement Within a Bond Pad

The placement of the probe tip within the bond pad was identified as a possible source of variation in third harmonic results. To evaluate this effect, 94 die on a production wafer measured with deliberate placement of the probe in the center and opposite corners of the bond pad (Figure 5). A newer probe card was used to make these measurements to reduce any variation due to probe tip wear. The probe card had been used for only 95,000 touches. We routinely achieve probe life in the 500,000 to 2,000,000 touches. The delta of the measurements from center placement to the corner measurements was calculated. A statistically significant difference of 0.14 dBm between the probe placements was observed (Figure 7). However, the difference was small, so in practice it is irrelevant (Figure 6). Probe placement within the bond pad is not the cause of the marginal reproducibility results of the Gage study.

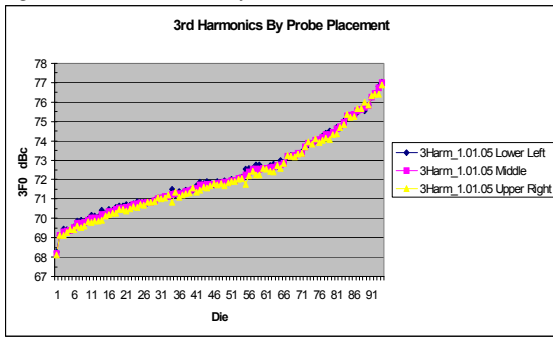
Figure 6 Third Harmonics By to Probe Placement within The Bond

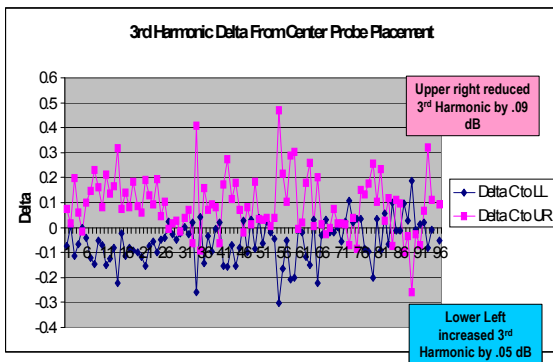
Figure 7 Differences in Third Harmonics Due to Probe Placement Within The Bond Pad

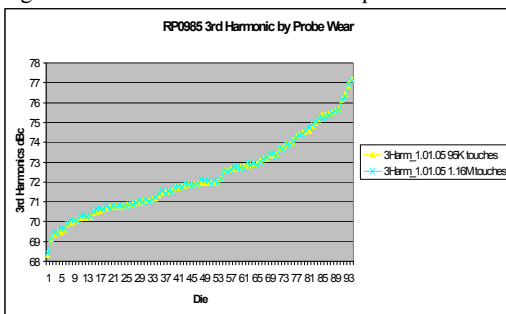
Figure 8 Third Harmonics vs Probe Tip Wear

The 1 mil diameter probe tips used for RF test are very small and fragile. During usage, the probe tips wear and change from sharp to dull. The probe marks left by a new probe tip are narrower and deeper than a dull tip, which tends to be wide and push more of the bond pad metal. This wear effect was identified as a possible source of variation in third harmonic results. To evaluate this effect, two probe cards were utilized. A newer card with 95,000 touches and an older card with 1,160,000 touches were used. Figure 8 shows the third harmonic results sorted from best to worst. Figure 9 shows the point by point difference between the two probe cards. There was no statistically significant difference observed between an old and new probe card. Probe tip wear is not the cause of the marginal Gage study result for reproducibility.

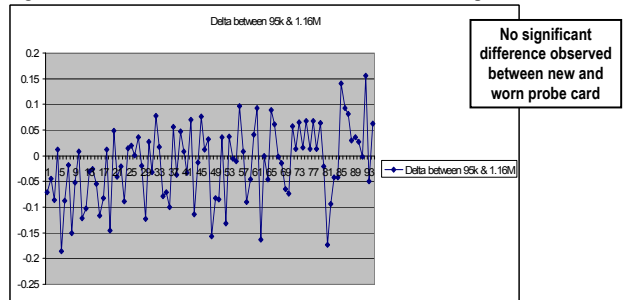
Figure 9 Difference in Third Harmonics Due to Probe Tip Wear

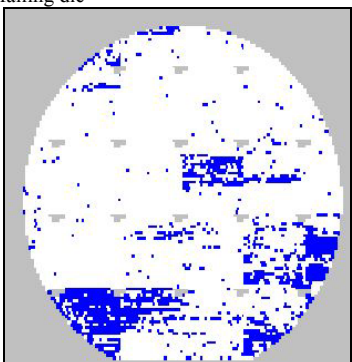
Figure 10 Wafer Map Showing Atypical Pattern Due to Probe Pressure. Blue color is for failing die

The operator is responsible for setting probe pressure using our EG4090 and EG2001 automatic probers. To ensure adequate probe pressure, the test engineering group at Skyworks developed a visual system to aid the operators. A wafer map is generated real time as the wafer is being tested. The map indicates passing die, functional die that fail, and non-functional die. Functional die are those which pass a minimal functional screen but do not pass the high performance specifications. The non-functional die fail the minimal screen. When die fail the functional screen, some special cause is at work. For example, an out of control process step, equipment failure, or operator error. The limits have been chosen such that poor probe contact is reported as non-functional die. When an operator sees excessive non-functional die, the probe pressure is one of the items to be checked (Figure 10). Typically, when probe pressure is insufficient, an abnormal pattern in the data is revealed.

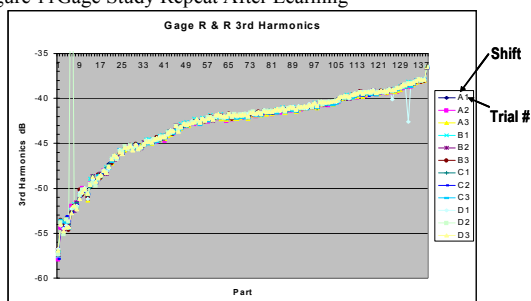
Figure 11 Gage Study Repeat After Learning

The Gage study was repeated with carefully controlled probe pressure. Once again, four operators were used in the study each repeating their measurements three times with the set up being redone after each measurement. The results showed the reproducibility improved from 14% to less than 1%. See Figure 11 and 12.

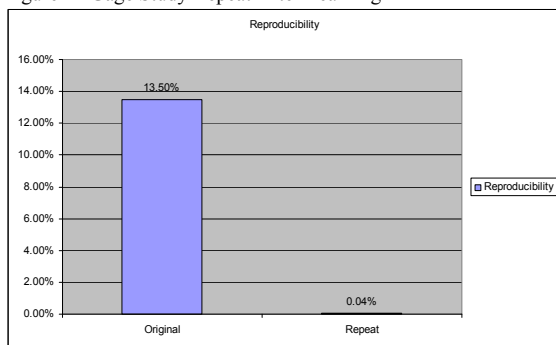
The 3<sup>rd</sup> Harmonic Measurements were both repeatable and reproducible. Each die was measured 12 times. 4 operators (on 4 shifts) measured each part 3 times. The Average range of the 12 measurements for 139 die was 0.48 dBm.

Figure 12 Gage Study Repeat After Learning

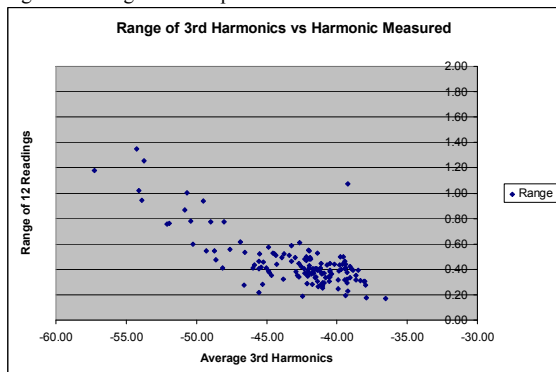
Figure 13 Range of 12 Repeated Measurements vs Performance

The range each of the twelve readings was calculated (4 operators, 3 times each) for each of the test data points. The range was then plotted as a function of the third harmonic performance. Figure 13 shows the range of measurements increases with increasingly better third harmonic performance. At -40dBm (100nW), the range of 12 repeated readings was <0.5 dB. Above -50 dBm (10nW), the range of measurements increases. This is likely due to reaching the noise floor of the test hardware.

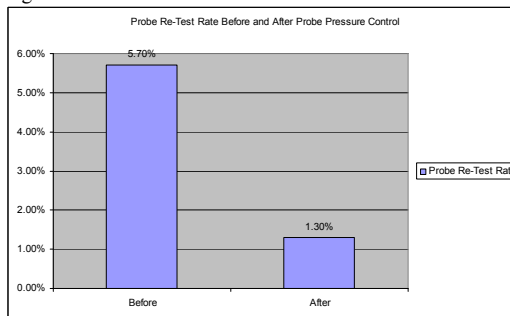
Figure 14 RF Probe Re-Test Rate Before and After Probe Pressure Control

After learning the significant contribution to variation in probe results that is caused by probe pressure control and implementing the visual aid for operators to recognize insufficient probe pressure, the need for re-test decreased (Figure 14).
